## **MMTO Internal Technical Memorandum #02-1**

### **Effects of CO<sub>2</sub> Cleaning and Detergent Washing on Specular and Diffuse Reflectance of the MMT 6.5m Primary Mirror**

**W. Kindred**

**August 2002**

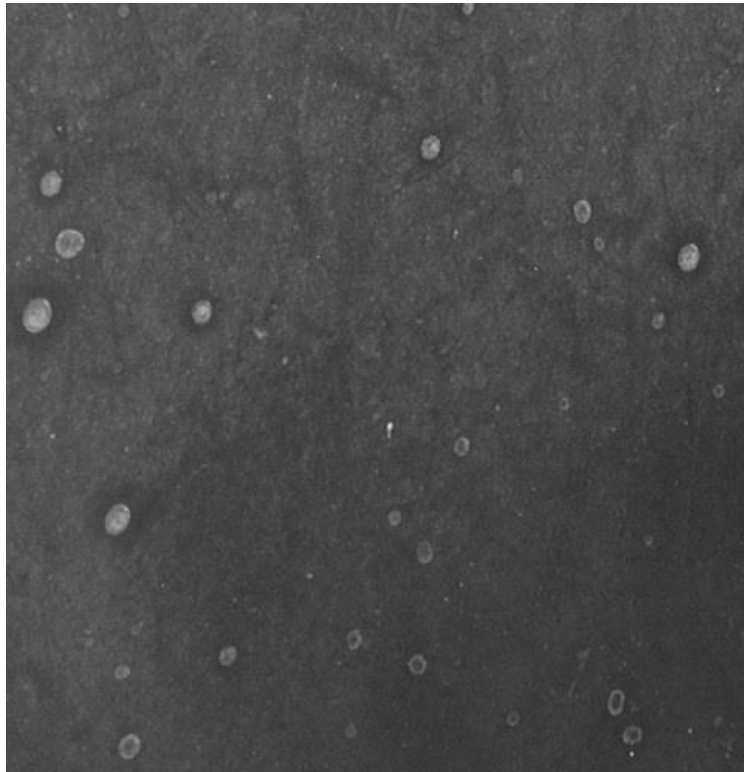
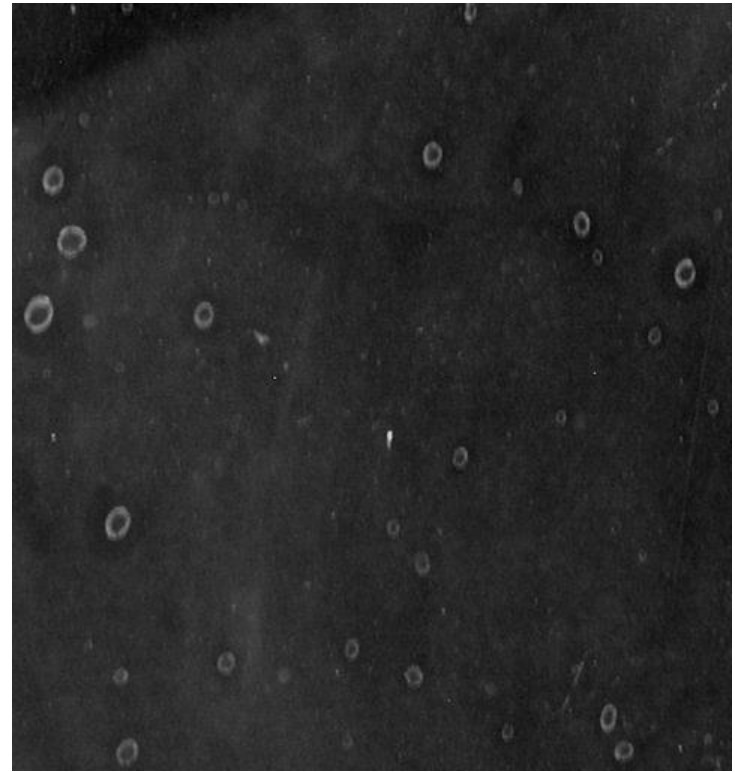
Each measurement above is the mean of three taken at six o'clock, about 90% zone on the horizon-pointing primary. Visually the primary appeared quite dusty (Figure 1 left). The water spot density was estimated at 1.5/in<sup>2</sup> in the worst areas. Mean diameter of these spots was about 3mm and the entire spot area was diffusely reflecting (Figure 2 left). CO<sub>2</sub> cleaning could not completely remove them—thin annuli remained, maybe 20% of the area (Figure 2 middle). Washing further thinned the annuli and might have completely removed a small percentage.

Figure 1. Before (left) and after (right) CO<sub>2</sub> cleaning. Mottling on the right is reflection of baffle felt.

Our measurement uncertainties notwithstanding, we obviously get the most return for our effort with CO<sub>2</sub> cleaning. In terms of reflectance we gain very little by washing this mirror. The scattering data suggest a modest improvement. I surmise that this small gain will be short lived however, rapidly disappearing, perhaps within weeks of again exposing the mirror to the elements.

Based on these results we decided to forgo washing at this point. The substantial effort and risk involved does not justify the gain.

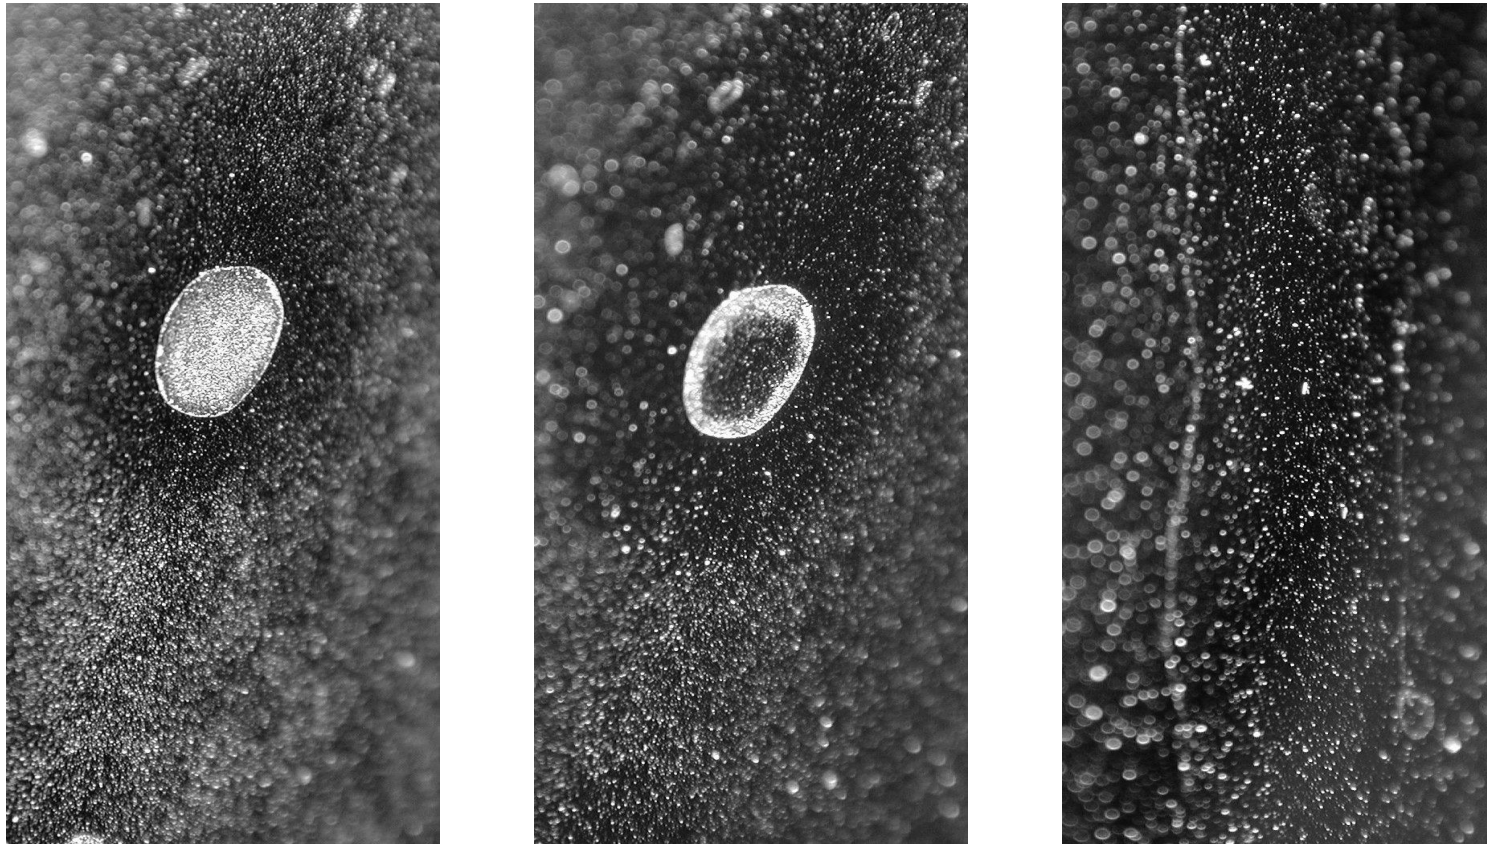
Figure 2. Before (left), after CO<sub>2</sub> cleaning (middle), and a different area after washing (right). Note the low-scatter areola surrounding the water spot(s), etiology unknown.
