MMTO Technical Memorandum #03-4

Modifications to the f/9 Secondary Mirror Hardpoints

MMTO Technical Memo #03-4, 18 Feb. 2003

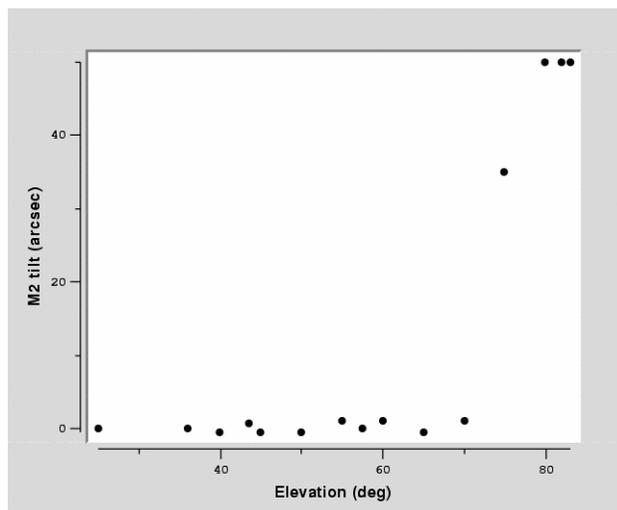
Once installed on the telescope, it was soon realized that mirror had a rather large position discontinuity near 75-degree elevation (Figure 1). After the installation of the light baffle in 2001, the position of the secondary mirror relative to the primary became erratic causing large non-repeatabilities in the collimation (Figure 2) and high frequency image oscillations in the presence of wind. Taken together (and after some tests verifying the integrity of the OSS top end), this implied that the hardpoint system that defined the position of the secondary mirror within the cell had become unreliable. Presumably, the baffle significantly increased the wind vibration on the f/9 support system causing a degradation of its performance.

Figure 1: The first indication of a problem with the f/9 mirror system manifested itself (in June 2000) as a collimation discontinuity for high elevation. This graph was obtained before the telescope wavefront sensor was implemented by using an out-of-focus star image and tilting the secondary vertex until the secondary shadow was centered as a function of elevation (nulling coma visually).

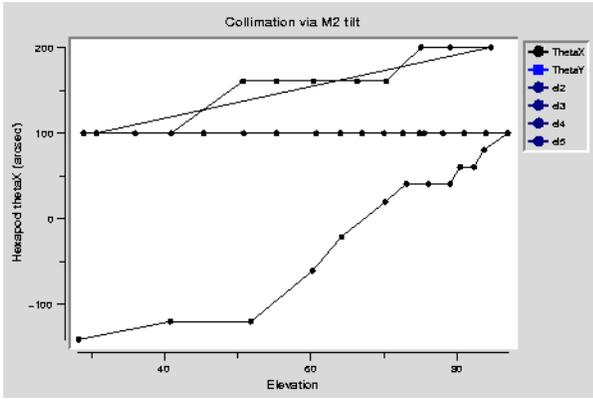
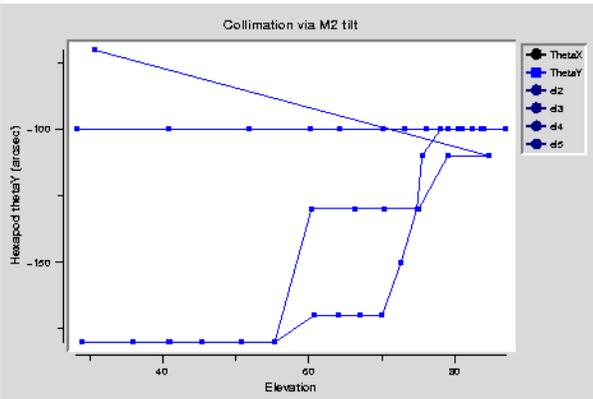
Figure 2: Examples of the erratic collimation behavior vs. elevation that occurred after the f/9 secondary baffle was installed. An out-of-focus star image was used to null coma by tilting the secondary vertex in thetaX (top) and thetaY until the secondary shadow was centered in the pupil.

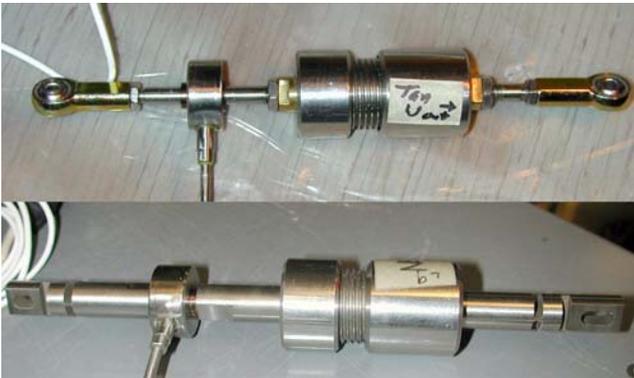
Figure 3: Original (top) and modified f/9 tangent arm assemblies. The MMT0 modifications consisted of removing several jam-nut connections in the shafts and replacing the rod-ends with flexures. Additionally, minor maintenance was performed on the breakaway mechanisms.

The tangent arm modifications (Figure 3) concentrated on simplifying the arm struts by removing the jam-nut connec-

tions and replacing the rod-ends with flexures. The axial hardpoints modifications (Figure 4) consisted of removing jam-nut connections, replacing the rod-end with a flexure, and stiffening the hardpoint spacing columns and upper tower.

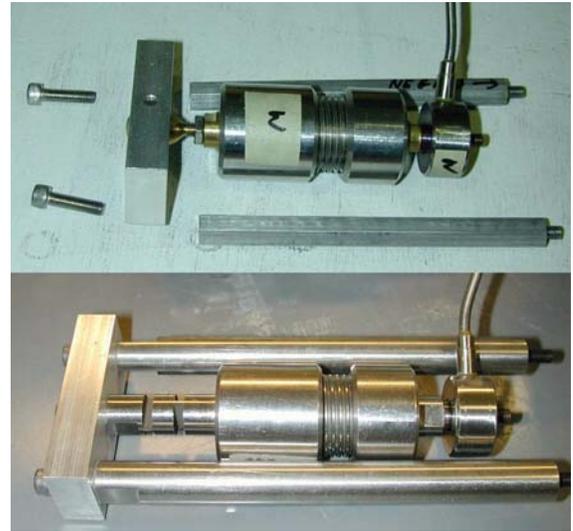
Figure 4: The original (top) and modified axial hardpoint assemblies. The jam-nut connections were eliminated, the rod-end was replaced with a flexure, and the column spacers were stiffened.

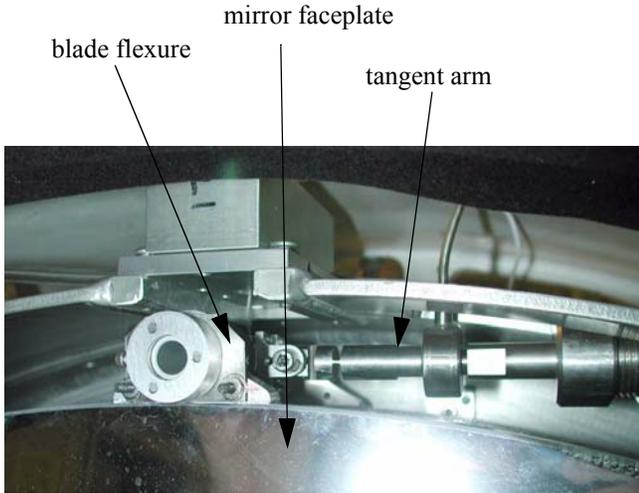
After close inspection, we discovered a single-point contact of an axial earthquake pad with the mirror backplate. After eliminating this contact, the lateral support servo was still unstable

in the region of the discontinuity suggesting compliance in the load path from the tangent arm load cells to the mirror.

The cause of the compliance turned out to be the three linear bearings that are in the direct load path between the tangent arms and the edge of the mirror frontplate. A blade-flexure was designed to be placed in parallel with each linear bearing (Figure 6). The thin membrane flexure significantly reduces

Figure 6: Blade flexure solution that ultimately eliminated the high-elevation collimation discontinuity and lateral servo instabilities.

the radial compliance of the linear bearing while still allowing axial compliance [parallel to the mirror’s optic axis] for the CTE mismatch between the glass and lateral support columns.

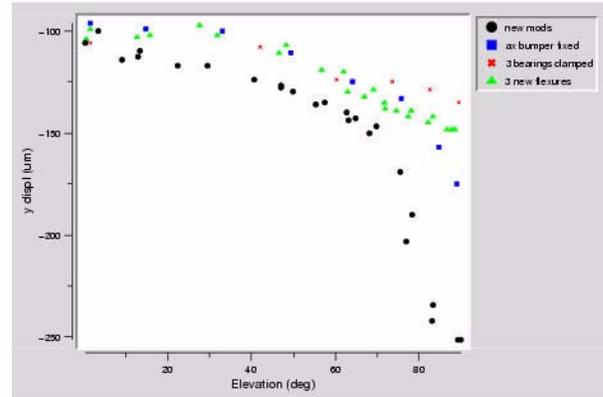
Although the newly modified hardware would surely increase the robustness of the mirror defining points in the presence of wind buffeting, the modifications did not eliminate the high-elevation collimation discontinuity shown in Figure 1. Additionally, we noticed that the lateral support servo became unstable in the region of the discontinuity. Extensive testing of the electronics failed to show an electronic problem.

Figure 7 shows the elevation dependence of mirror position for the various steps in the modifications described above. Note that the simple beam flexure of the aluminium post that connects the tangent arm to the bearing flexes by 30 microns, so that the displacement shown in the graph for the “clamped bearing” case is near the theoretical flexure for the geometry.

Figure 7: Graph showing the progress in reducing the elevation dependence of mirror position within its cell. After the hardpoint modifications (black), the collimation discontinuity was still present. Removal of the axial earthquake interference reduced its magnitude (blue), but the elevation servo was still unstable in this region. Clamping the 3 linear bearings in the direct load path between the tangent arms and the mirror eliminated the discontinuity and elevation instabilities (red). The final blade flexure solution (green) is not as stiff as clamping the linear bearings, but allows for axial compliance for the CTE mismatch between the mirror and lateral support connection columns.
