Azimuth Servo Upgrade Progress Report #1
October 29, 2009
D. Clark

Introduction

This is the first of a series of reports detailing progress on upgrading the MMT azimuth-axis servo system. In this report, work on the first few items on the Azimuth System Test Plan is detailed, including presentation of the first practical measurements performed on the azimuth hardware.

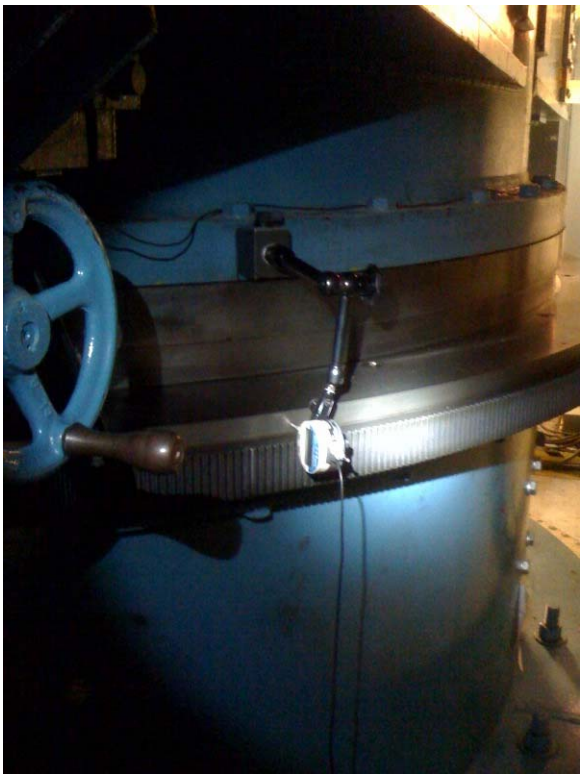
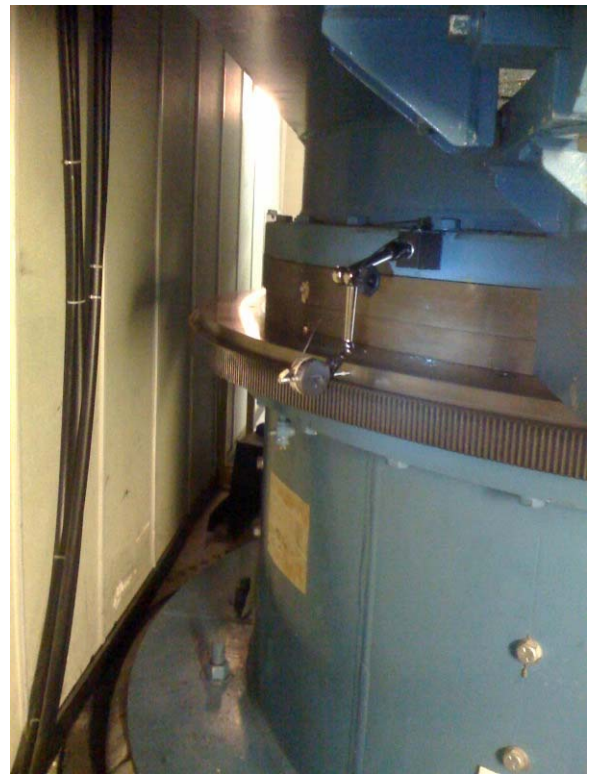
The dial indicators were installed as pictured (West on the left, East on the right):

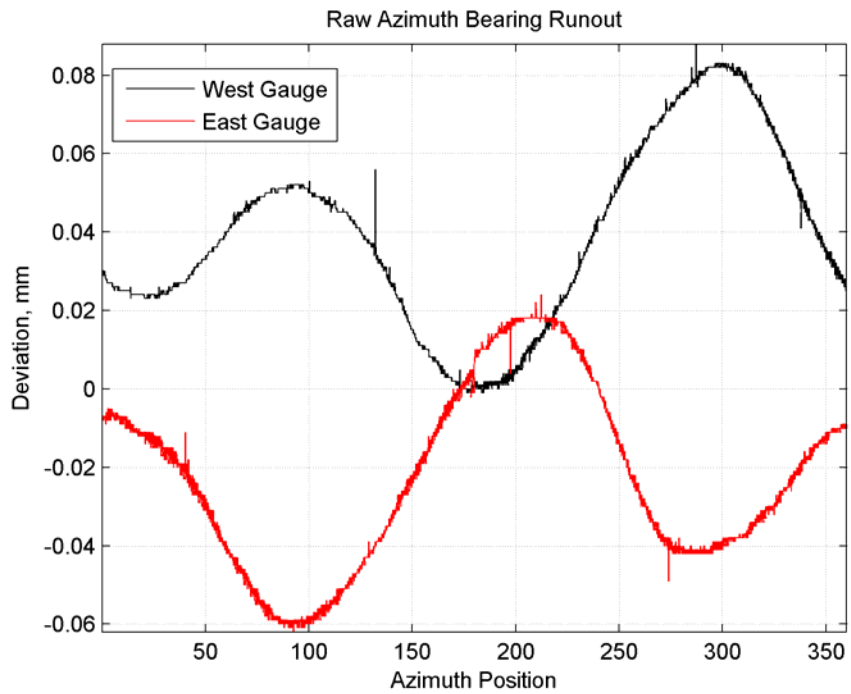
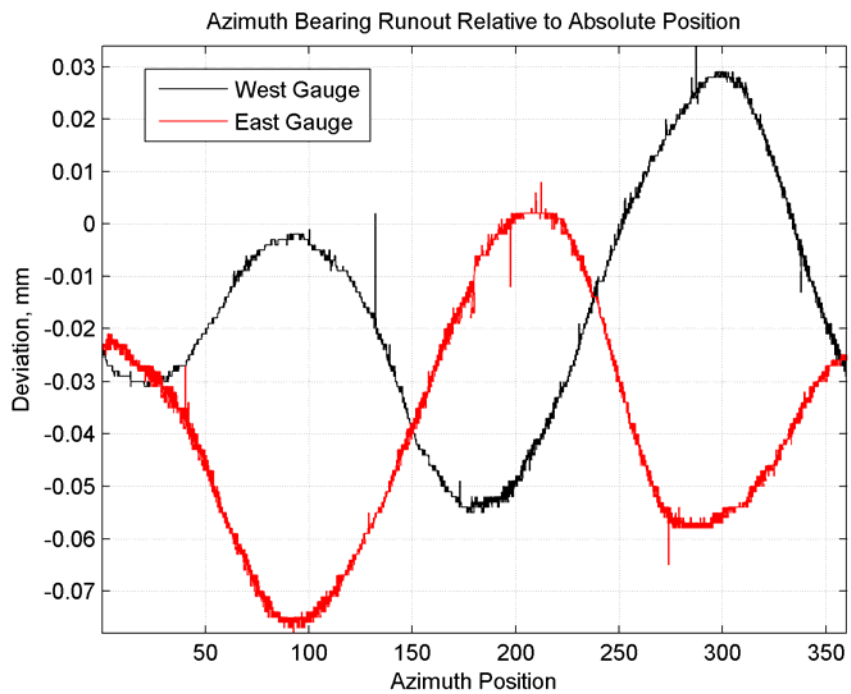
Below we have graphs of the two dial gauge measurements against the azimuth position:

The first plot shows the raw data as it was collected from each dial indicator against the telescope position; the second the same data where the dial indicator data is “clocked” to bring the measurements into alignment with the absolute azimuth position. Below we have the two orthogonal measurements reduced to a polar-coordinate vector that represents the absolute runout over the telescope position. The dial gauge readings were each offset by 0.1mm to show how the runout varies relative to a constant radius; it makes much clearer how the mechanical center of rotation changes over position.

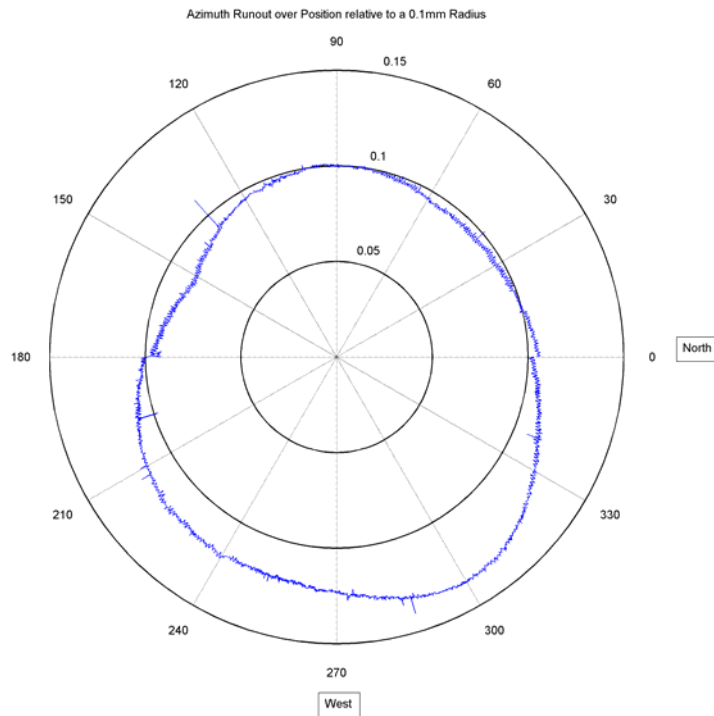
Since the dial gauges were re-zeroed at the beginning of each data run, we see the sharp inflection in the data where each indicator was reset or motion was stopped (at 0 and 180°) -- a better method of continuously collecting the data would avoid this measurement distortion.

The total radial runout of the MMT azimuth bearing is a remarkable peak to peak value of about 0.09mm. If this deviation is projected to the height of the elevation bearing centerlines (a distance of about 6.8m), the angle subtended by the radial bearing wobble is roughly 2.7 arcseconds over an entire azimuth revolution. It would be interesting to compare the data shown here to TPOINT coefficients from recent pointing data to see if this relationship holds.
