I've been very tied up with shutdown chores but had some time to look over

the slew file data from the very disturbing elevation collision on 7/31. A

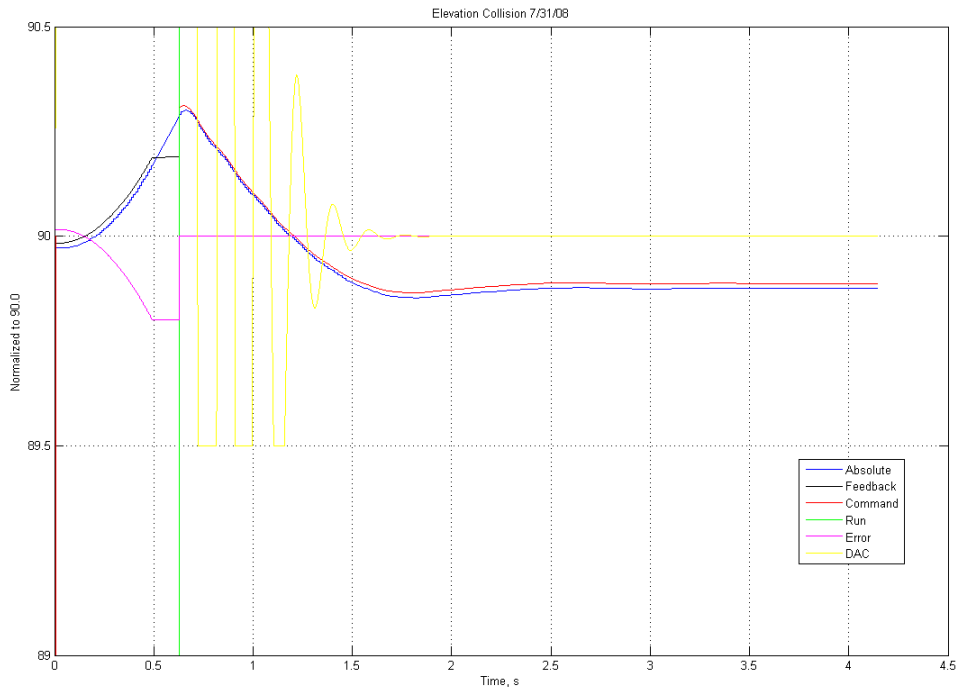
Attached are two plots with the absolute encoder, tape feedback, command signal, run status, position error, and dac signal all overlaid in time and normalized to the position of 90 degrees, on for the first 4 seconds of the (16.5s) complete file, and another that zooms in on the first second or so.

First, consider the unzoomed plot. Here we see that the event began with a command signal (red) that went from 90 to 89 degrees. At that time, the run status (green) was true, and the position error (magenta) was positive non-zero. The absolute encoder (blue) shows the telescope moved up, opposite to the commanded direction. Indeed, the DAC signal (yellow) remained railed positive. At approximately time 0.5s, the position error check must have tripped, freezing the position error when it exceeded 0.2 degrees. This appears to have also frozen the tape position feedback signal (black), because it then fails to track the real absolute encoder position (blue). The absolute encoder faithfully records the telescope moving up, and the run status goes to 0 a bit later at time ~0.62s, resetting integrators and what have you in the controller (was this the final limit interlock switch tripping?). However, a side effect appears of rapidly switching the command signal from 89.0 to 90.3. The command and feedback are likewise switched to the same value, zeroing the position error. A bit later at about 0.72s, the DAC finally switches from positive rail to railed negative, and then enjoys several cycles of rail to rail switching at about a 0.12s period.

Several questions/concerns/comments about what I see here. First, we started out without the DAC at the rail, which quickly became railed. Why?

Next, the feedback shows the telescope moving opposite to the command, as if the feedback sign had been flipped; obviously this would guarantee a runaway. Once the position error check trips, it turns off the feedback signal to the controller. I can think of no good reason to do it this way;

you've opened the control loop up at that point, and the position error is set to some non-zero constant. The status signal delays 150ms or so before

it changes, and we appear to then get a spurious command signal to 90.3 degrees. The DAC signal is not zeroed, but allowed to swing rail to rail

when the final limit (I think) is exceeded. If this is the case, the DC bus on the amplifiers takes time to fall down, so even if the interlock system tripped, there could still be torque available to the drives for a

1. Telemetry files without corrupted ascii lines, please. I spent considerable time working around this issue.
2. Don't turn off the controller feedback. Do zero the DAC.
3. Spurious command signals that exceed the allowable position range? Not good.
4. Detect railed DACs that don't have motion associated with them...is a brake stuck?
5. Detect motion opposite to commanded motions -- loss of encoder/sign flip? Should not happen, if it does, kill the drive QUICKLY.
6. 0.1 second delay in run status trip? Interlock computer delay?

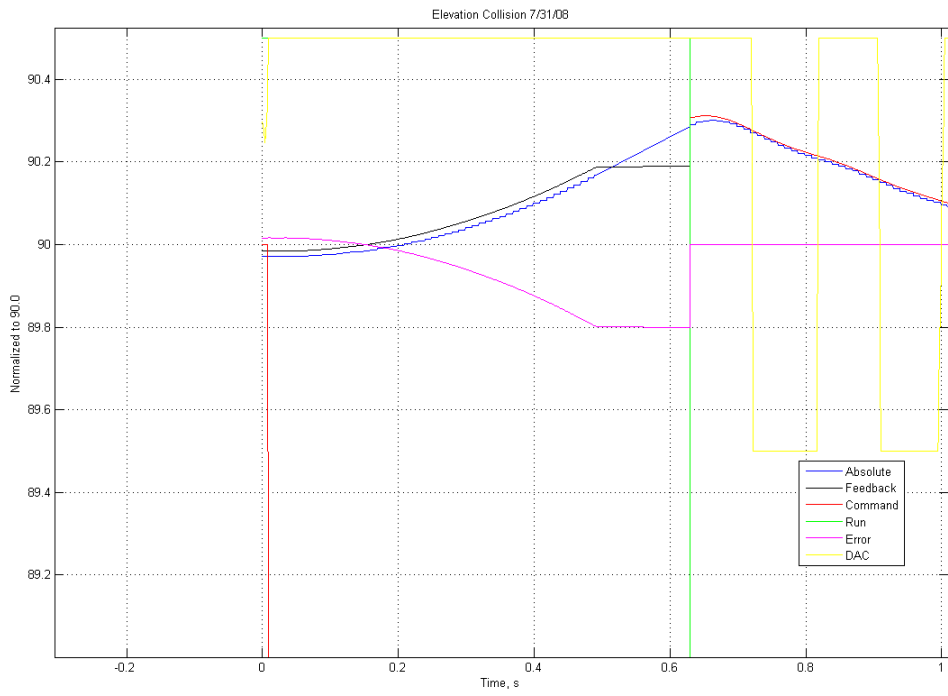
Next, let's zoom in on just the first second or so of this event. Here we can see the command was 90.0, then set to 89.0 at about 9ms or so. Note that the DAC was NOT railed at the beginning, though it rapidly goes to the positive rail at about 10ms. The position error at this time was 0.02

degrees, and began going negative starting at about 0.17s. The absolute encoder tracks the position error curve with the opposite sign. The run status was true for the entire first portion of this event.

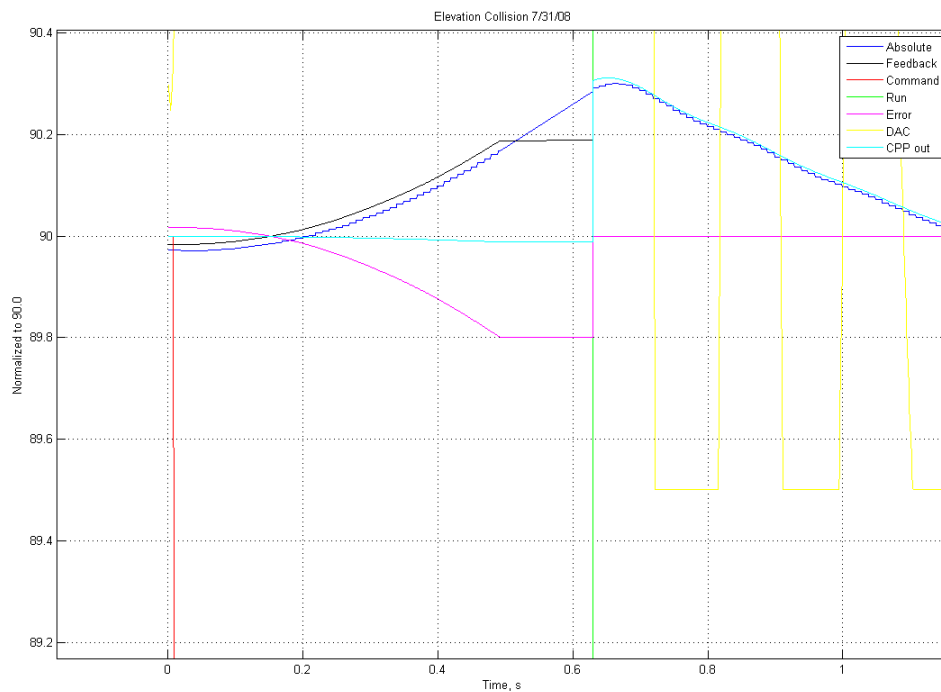
One more thing I've added to the plot of the collision is the command pre-processor output (cyan) to the controllers position loop. Clearly, it is getting switched at the same time as the other signals from the preprocessed value it was outputting to command 89.0 to 90.3 degrees. This is wrong. The CPP is there to protect from rapid accelerations of the telescope that could damage things, and we had a) motion in the wrong direction to begin with, and then b) an unprocessed command output that was beyond 90...so it's to fix.
