Options for Repair of Elevation Tape Encoder Scales
January 26, 2010
D. Clark

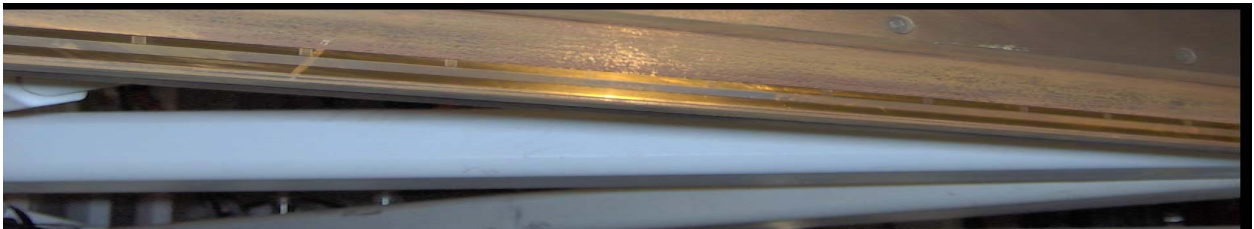
Figure 1 West Tape at ~23 degree position

The elevation tape scales have been damaged by an as-yet undiscovered source. Below, we have some pictures of the damage. It's a little hard to see, but the dark areas are places where the gold overlay has been knocked away. The West tape is pictured at the position where the tape encoder head reads at 23° elevation. The East side is out of focus and a bit harder to see, but the dark areas are visible if examined carefully:

Careful examination with a surface-inspection 40X microscope shows that the scale graduations are still present, but the gold overlay is definitely scraped off. This makes the encoder read head output signals to drop below their specification level due to the lessened reflectance in those areas. I looked for any evidence that the ventilation hoses may be “walking” over and damaging the tapes but cannot say definitively they are at fault. I also have no good idea why the tape head alignment appears to have become so far out of spec.

Prudence dictates that before spending large amounts of money on new tapes, we do our best to recover proper tape encoder operation. To that end, after consultation with JT, I recommend the following short-term action now that normal elevation movements can be performed using feedback from the absolute encoder:

1. Starting with only one tape, remove the head and mounting bracket.
2. Inspect the tape head face for damage to ensure it is not the source of the rub damage.

3. Mark the tape end mounting locations and remove the tape from the drive arc.
4. Clean all rust and grease from the tape mounting surface and side edge.

5. If feasible, phosphate-coat the unpainted steel tape mounting surface to prevent more rust from developing.
6. Inspect the tape scale carefully and note any damaged or worn/scratched areas.

7. Mark (via carbide scribe) an axial reference line to re-mount the tape against to ensure the tape is square to the plane of elevation motion and has low lateral variation.

8. Measure via our runout-measurement tool the axial and radial runouts of the tape surface to ensure proper alignment. This would be a good time to calculate the air-gap variation expected over temperature once the overall radial runout is known to ensure the air gap is set wide enough to tolerate warm-weather operation (could warm metal have cause the air gap to close and damage the tapes in "high spots"?).

9. Re-mount the tape against the newly scribed axial reference line. If desired, this could be deferred until after aluminization to preclude any new damage from handling the mirror cell vacuum closures.

10. Install the adjustable head mount and adjust the head location to align the tape as well as possible.
11. Check the tape output across all operation positions to ensure proper operation, or identify any areas where the tape is not working well. We would do well to ensure the elevation controller runs the position loop ONLY on the absolute encoder at low elevations (below 5°) to ensure that we don't again have problems safely closing the servo loops if the tapes aren't perfect.

12. Implement any additional safety covers or other methods that may be feasible to ensure the tape cannot be accidentally hit with ventilation hoses, cables, or other equipment and become (more) damaged.
