## End of Trimester Summary

January – April 2011

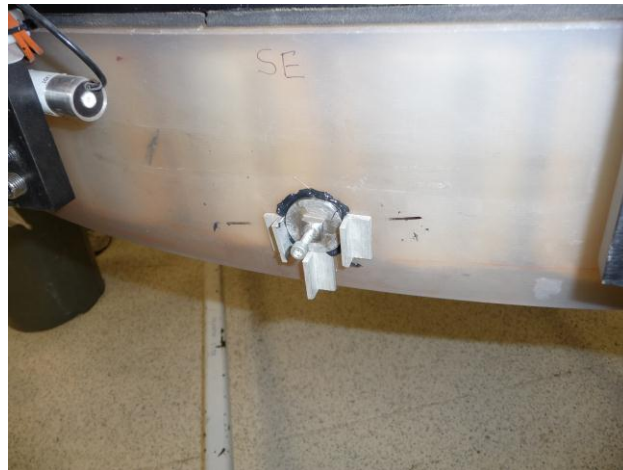
Figure 1. Tangent rod puck installation brackets

The tangent rods were reattached and aligned to optimal position. Tangent LVDTs were adjusted to near mid-stroke for reduced noise levels. The center plug and rotational plug were inserted with no problems. (The rotational plug tines had sprung due to material issues and had to be turned to the diameter of the mirror metrology hole.)

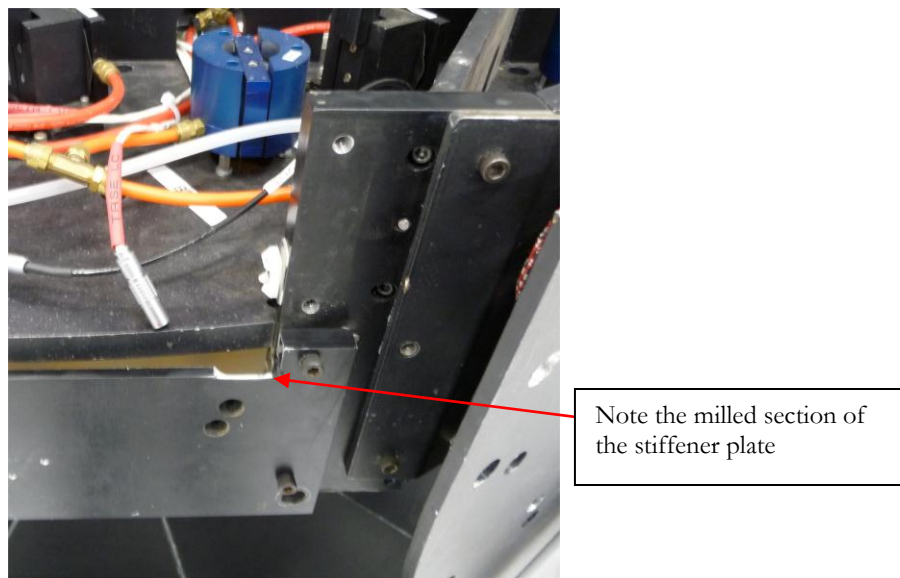
Figure 2. Stiffener plate with milled slot.

A thorough inspection of the mirror cell identified loose hardware on the stiffener rib. All screws were removed and locktite was applied to the threads prior to reinstallation. All air transducers were removed, locally calibrated, and reinstalled. The southeast transducer was found to be sensitive to angular motion and was replaced as a preventive measure. The clear air lines used throughout the cell, which appeared to be cracking and leaking, were replaced with green tubing. Several actuators required adjustment. The load placed on each axial actuator should be the same when the mirror is suspended in a nadir pointing position. Actuators G31, G28, G17, G22, G6, B11, B24, and B35 were all loose, i.e. not sharing the load. Each actuator was adjusted to show some load sharing. B22 would not adjust to show any load sharing when air was off. With the servo system on, it did carry a load. To allow easy removal of the tangent rods, a slot was milled in the side stiffener plates. The milled plates now allow removal of the tangent rod without removal of the side stiffener plate. The rubber bumpers around the mirror were inspected, and the one on the south side had a failed glue bond. It was reglued and reinstalled. All bumpers were adjusted while the f/5 was nadir pointing.

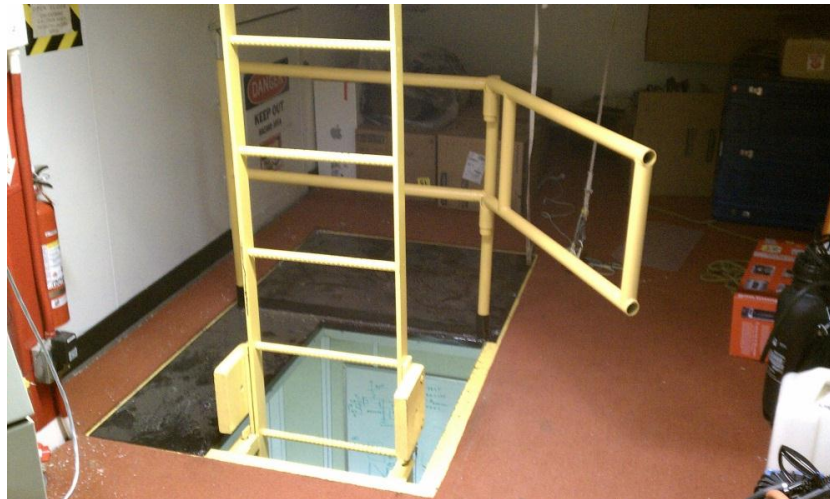
Figure 9. New guardrails installed in a 4<sup>th</sup> floor loft area.

Guard rails were designed, manufactured, and installed in both the 4<sup>th</sup> floor east and west lofts, eliminating the fall hazard.

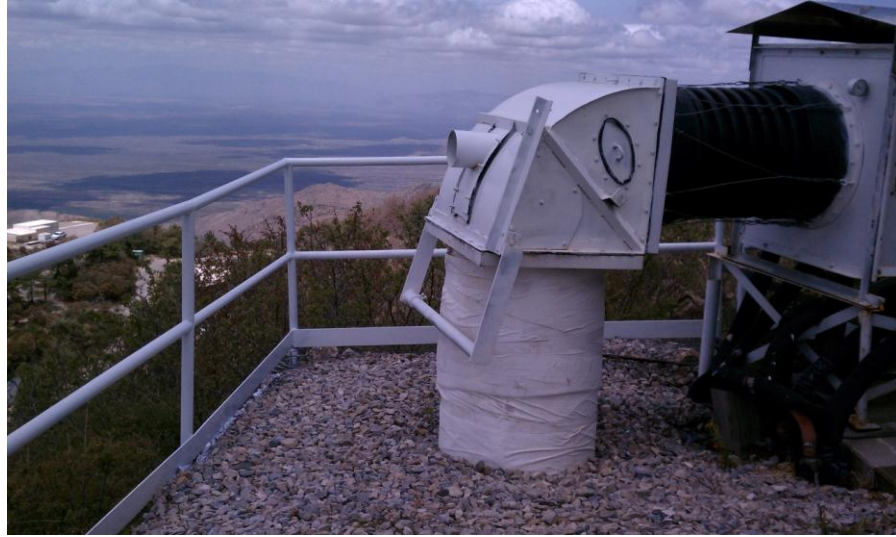
Figure 10. Guardrails installed around the shop heat exchanger.

Guard rails were also installed around the shop heat exchanger, replacing mule tape previously used to cordon off the area.
