BIMONTHLY SUMMARY

September – October 2007

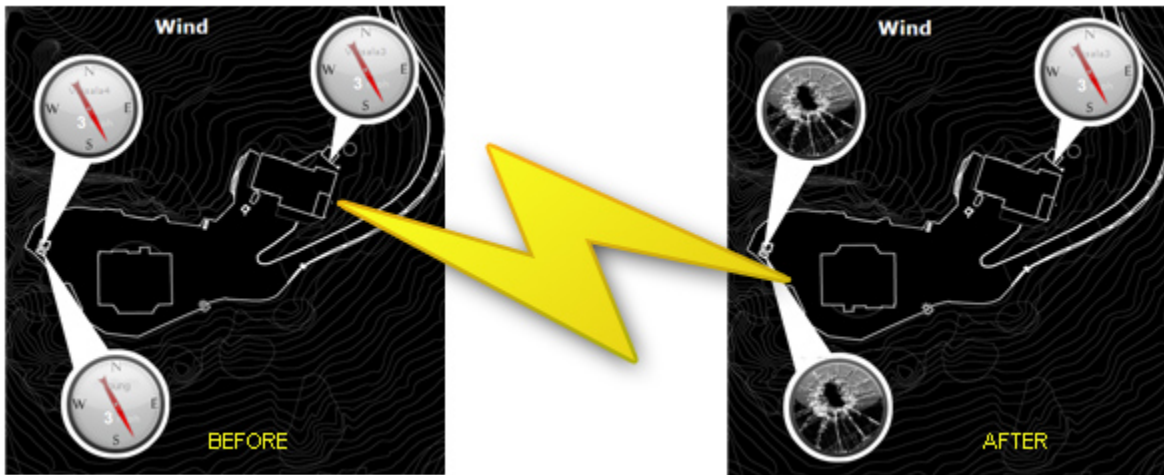
A screenshot, taken from a webpage created by Dallan Porter to help visualize data from three summit wind sensors, depicting before and after shots of the R. M. Young and Vaisala4 weather stations, which took a direct lightning hit on September 17, 2007.

The R. M. Young wind sensor, which was previously connected to a console in the control room, was recently converted to connect to the network using a Lantronix RS232-to-ethernet converter. To make use of the newly available data, Dallon Porter created a new “young1” miniserver and logging framework to make this data available online. A new webpage was created to help visualize the wind direction, speed, and sensor location for this wind sensor as well as the other two existing wind sensors (Viasala3 and 4). A miniserver was also created to record the “vaisala4” Model WXT510 weather station’s data. Unfortunately, shortly after the page went online, lightning struck both the R. M. Young and the Viasala4, taking them offline.

The R. M. Young anemometer and the WXT-510 weather station (vaisala4) were installed on the west weather pole at the summit. Both units, mounted side by side, displayed similar indications of wind speed and direction. Within a week they both took a direct lightning strike; we found some of the pieces. Damaged components in the power module at the base of the pole were replaced, and lightning protection devices were added. The WXT-510 was removed and sent back to Vaisala for repair. It was found to be defective and was repaired under warranty. It has since been returned and awaits installation. A lightning air terminal will be installed above the weather stations. Once the rod is replaced, the rest of the equipment will be reinstalled.

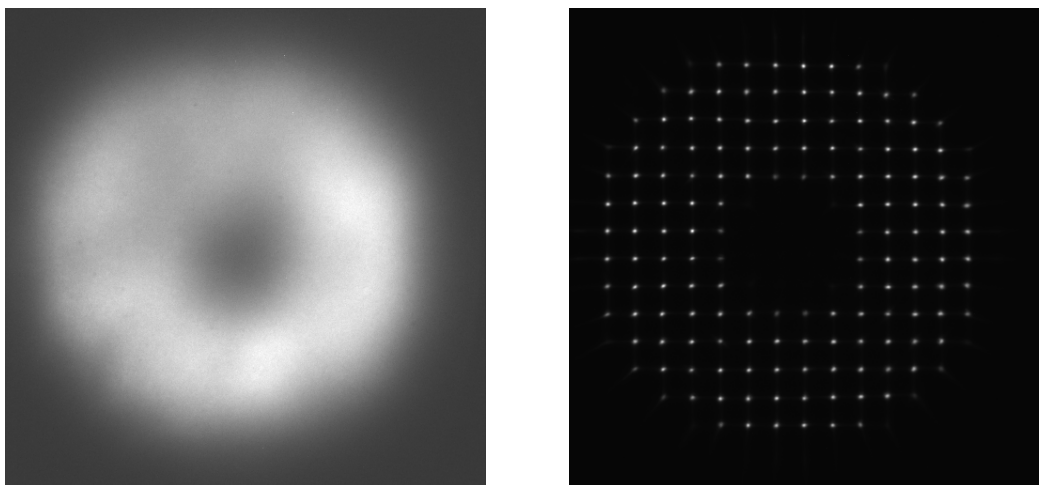
Once everything was working, we were beset with several nights of extremely poor seeing. The telescope operator described the resulting WFS images as "frosted doughnuts." The image on the left in Figure 1 below shows an example of how bad it was.

Figure 1: The exposure time of the image on the left was only 1 second, which further shows how turbulent it was. For reference, the image on the right (5 second exposure) shows what a WFS image looks like under 0.45 arcsec conditions. To completely smear out the WFS spots like that requires seeing of 10 arcsec or worse.
