End of Trimester Summary

May - August 2008

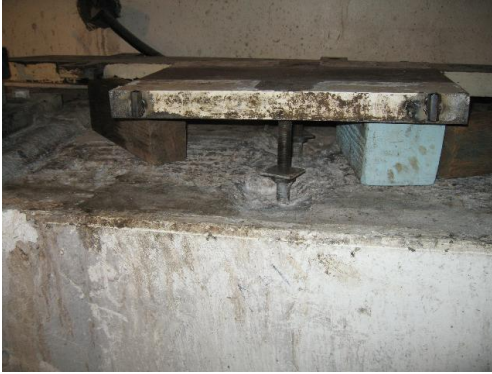
Several images from the regROUT of the track in the pit.

Two sections of the building track were regouted, and one section was shimmed. We also checked for levelness and verified that only three sections needed repairs at this time. The cow catchers were cleaned and aligned to the track. After regrouting, the track was cleaned and dry lube applied. The pit was also cleaned and organized.

Old grout has been removed and the track reset.

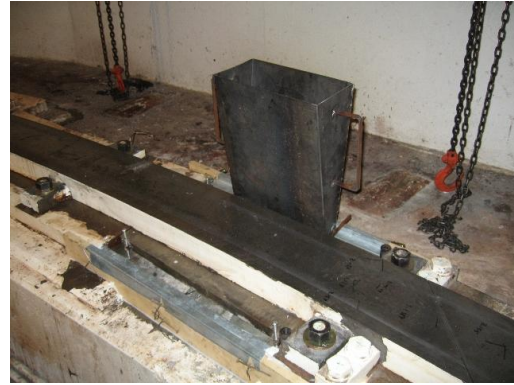
The track section alignment is verified, forms are readied for extruding cementitious grout under the track and sole plates.

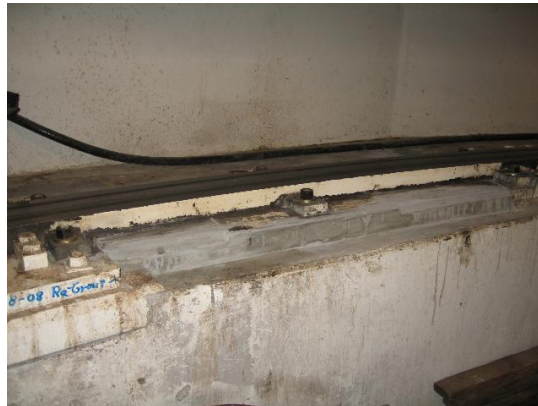
Grout is successfully placed; curing cycle is underway.
