End of Trimester Summary

May - August 2008

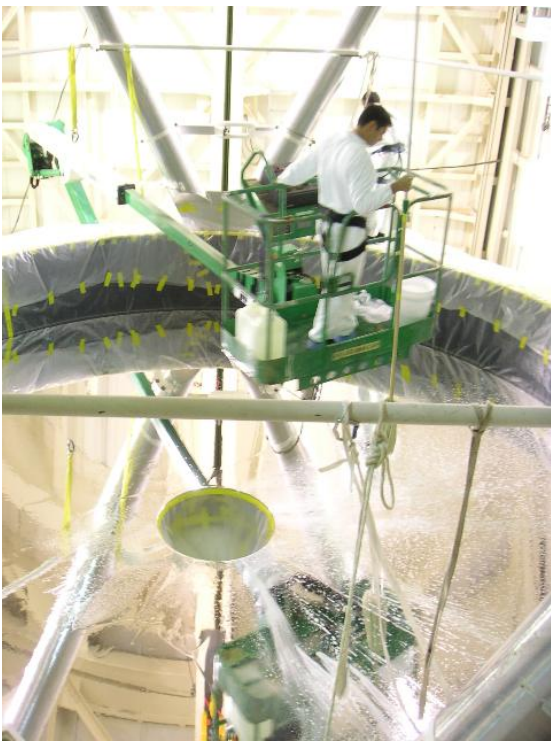
R. Ortiz maneuvers over the primary mirror while “dabbing” the surface with a soapsuds-filled large cotton swab.

The primary mirror was washed in mid May. We had a very successful wash by a dedicated crew who endured the strain of the task. Thank you all for lending a hand with this delicate and demanding step. It should maintain the coating for another year!

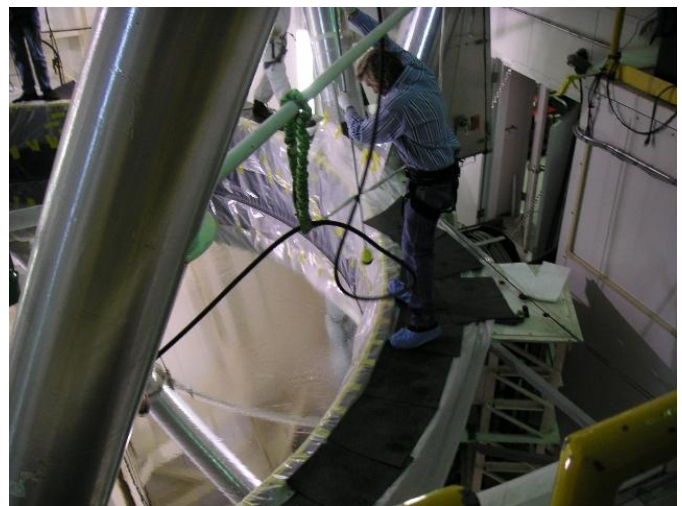
The mirror edge is “blown-dry” with filtered high pressure air.
