## BIMONTHLY SUMMARY

September – October 2005

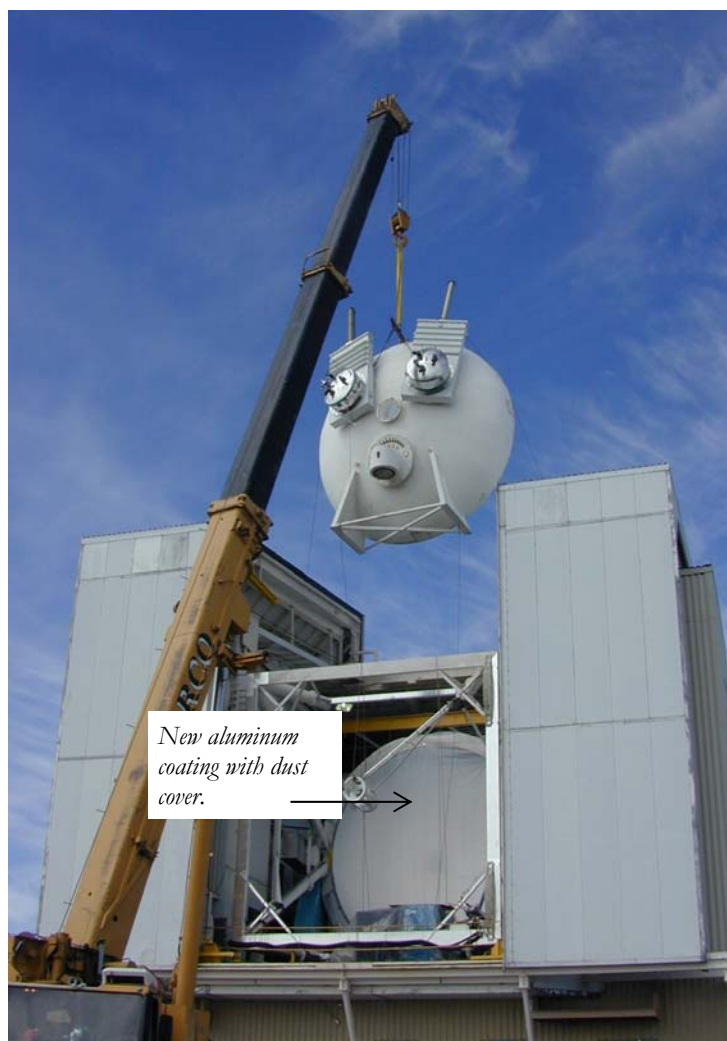
*New aluminum  
coating with dust  
cover.* →

*Removal of the vacuum head, with two cryogenic pumps and valves, following successful re-aluminizing of the MMTO 6.5-m primary mirror. Photo by Ken Van Horn (MMTO).*

The 6.5-m MMTO primary mirror was successfully re-aluminized September 27. After weeks of preparation and delays, all critical systems worked well and the optimum coating was deposited with only minor hitches. The coating is uniform and classical pure aluminum in all respects. Measurements on test plates show the aluminum to have textbook reflectance of 91.3% in the blue spectrum (4500 Å) with very low scattering indicated. Crystal monitors measured the thickness at nominal 930 Å near the mirror center. Excellent adhesion was verified by “scotch tape” tests.

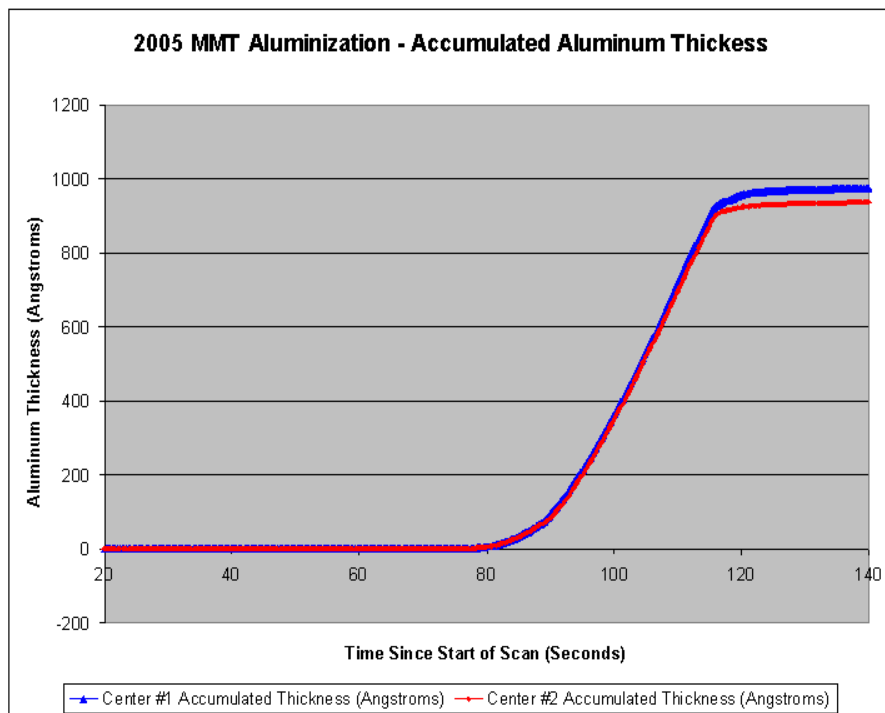
a) A plot of accumulated aluminum thickness.

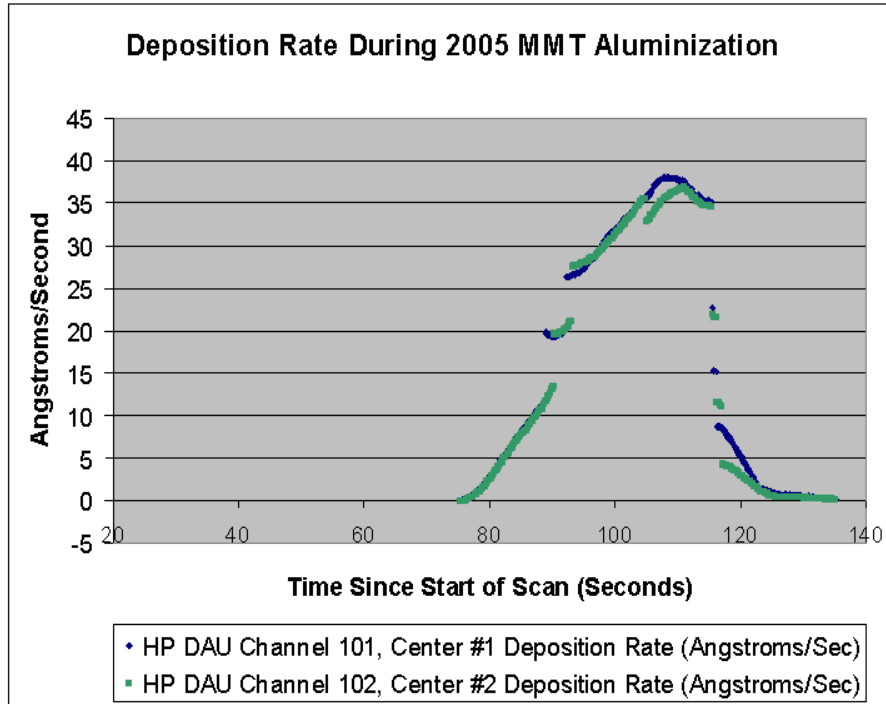
b) A plot of the aluminum deposition rate as measured at the center of the mirror during the ~60 seconds of aluminization.

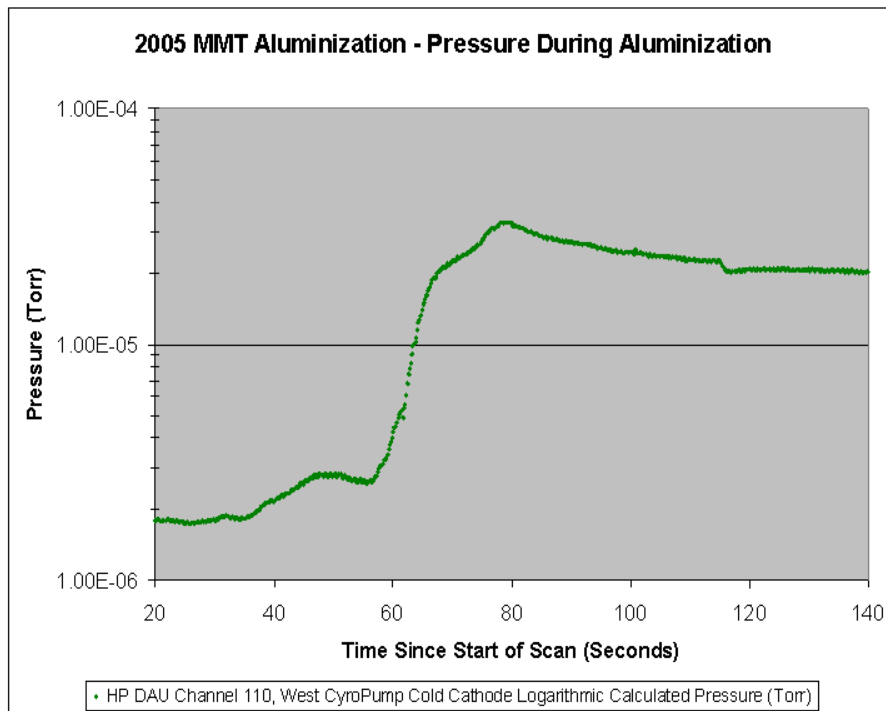
c) A plot of belljar pressure during heating and aluminum deposition (Torr).

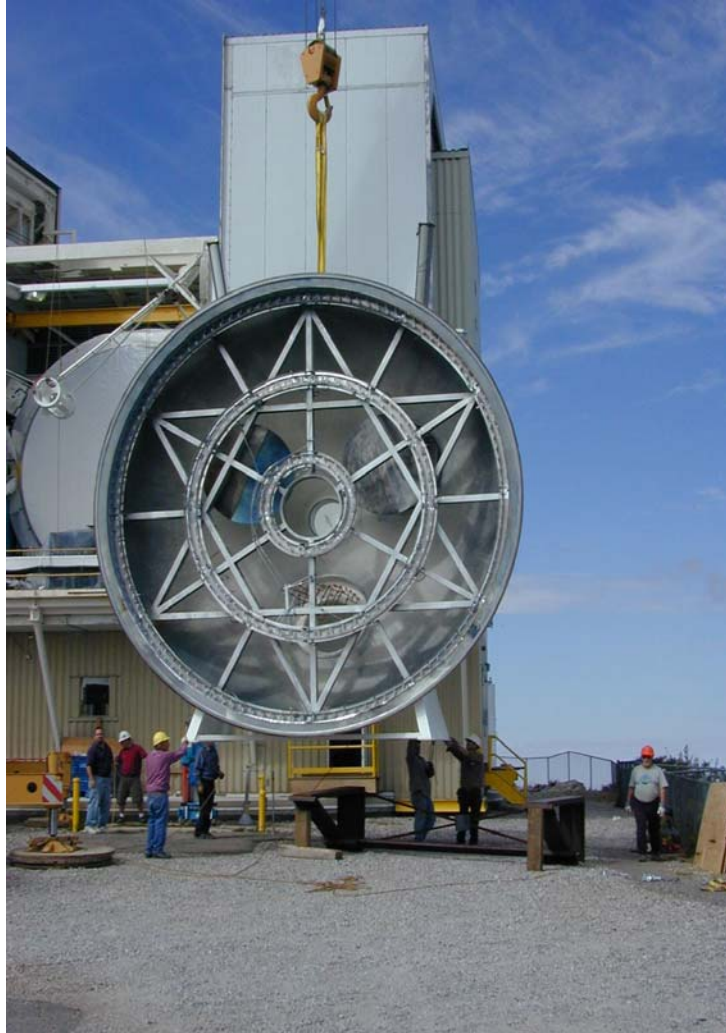
**d) The vacuum head (belljar) is prepared for rotation to horizontal, and storage.**
