BIMONTHLY SUMMARY

January - February 2002

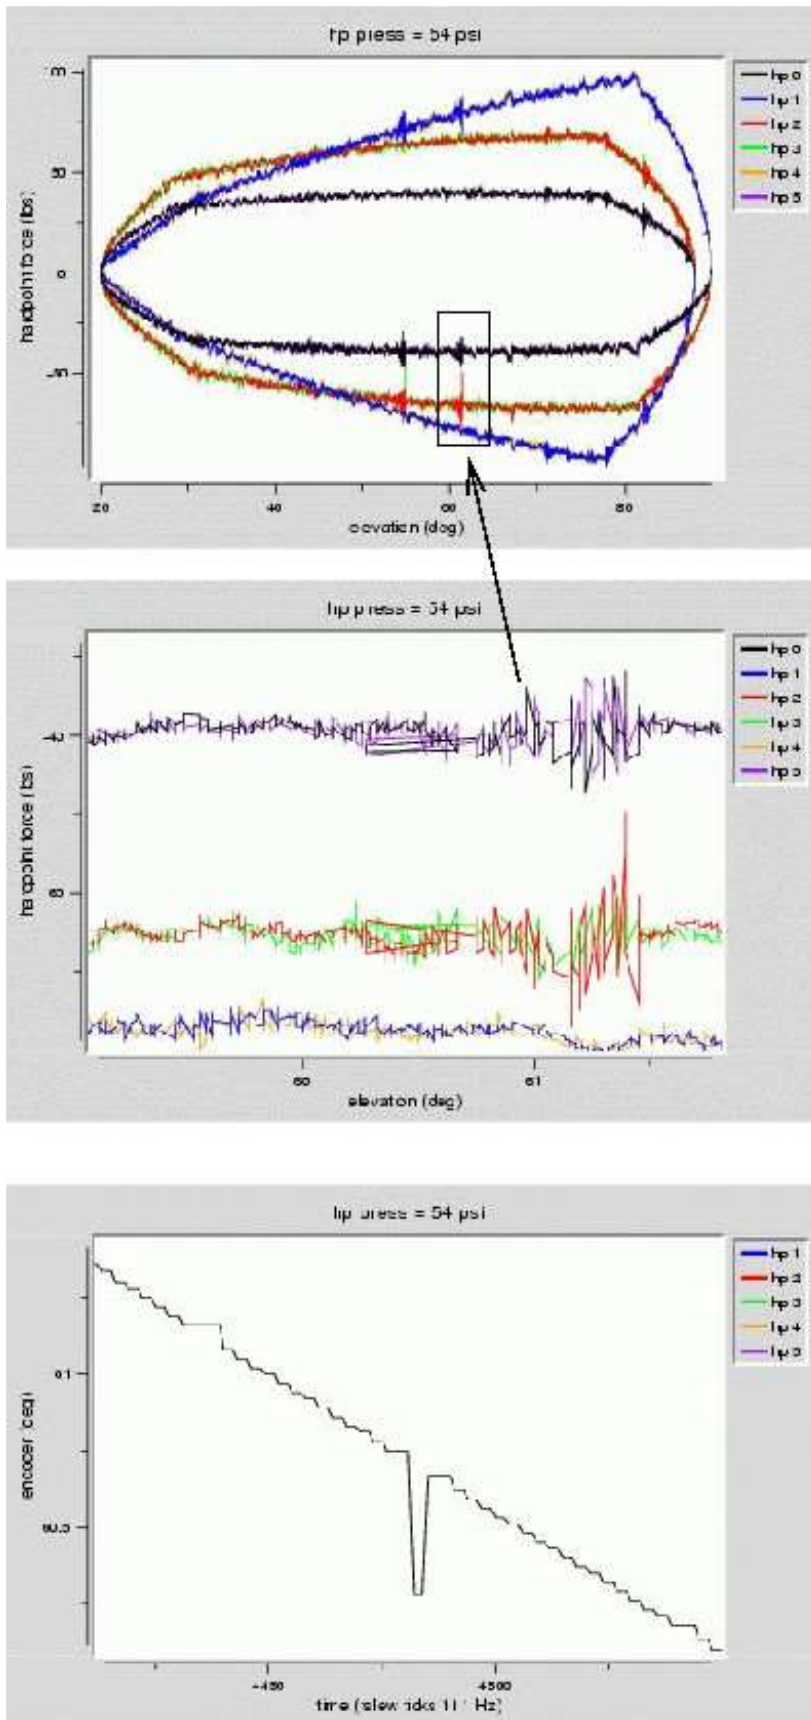
After a significant amount of investigation, it was determined that the tracking performance at the MMT is compromised significantly by two effects: 1) compliance in the elevation drive system that limits stiffness, and 2) an occasional discontinuity in the apparent az-el coordinates as measured from the absolute encoder.

Until this reporting period, it was not clear whether the coordinate discontinuity was just a display artifact or a physical problem with the drive/encoder system. We have determined that it is the latter. While slewing the telescope in elevation, the hardpoint forces were being monitored at 111 Hz. Figure 1 shows a plot of the hardpoint forces vs. elevation for a complete slew cycle between 90 and 20 degrees. The ringing in the hardpoint forces was suspicious, and upon further examination we found that elevation discontinuities impulse the telescope structure (as shown in the lower two figures).

Figure 1: Hardpoint force (y) vs. elevation during slewing (top). Middle shows zoom of hardpoint force during a ringing event. Zoom of elevation encoder (y) vs. time showing that an elevation discontinuity causes the structural ringing in the hardpoint platform (bottom).

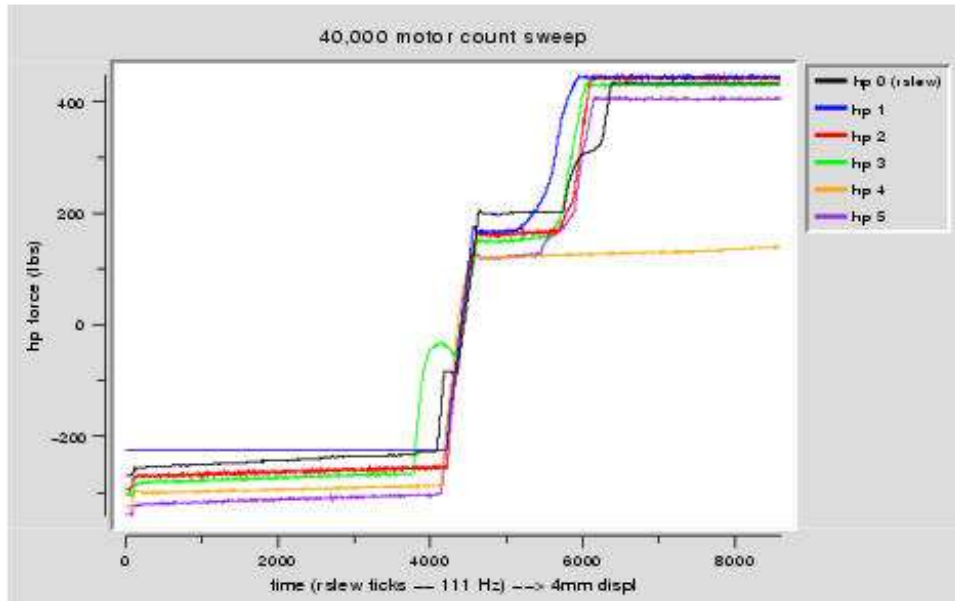
However, the primary mirror hardpoints have continued to cause intermittent collimation problems. Two more hardpoints required removal and correction of soft breakaway mechanisms. Modifications consisted of re-gapping and changing the number of springs in the breakaway mechanisms of the problematic hardpoints.

through the region from tension breakaway to compression breakaway. The results are shown in Figure 5. The hardpoint profile behaves as generally expected. As the hardpoint length is changed while in the tension breakaway (left side of graph), the force changes very little. The stiffness becomes large when the hardpoints finally “lock-up,” and then the compression breakaway is characterized by two levels corresponding to the spring forces and then the air pressure (hardpoint #4 [gold] shows no air pressure breakaway because it has an exceptionally large spring gap). Two hardpoints show a discontinuity in their “lock-up” profiles that appear to be some type of stick-slip behavior for small negative forces. The worst case (hardpoint #3: green) will be replaced during the next engineering run.

Figure 5: Primary mirror hardpoint breakaway profiles. Hardpoint force (Y) is plotted against time for a constant velocity scan of the hardpoint length corresponding to 4 mm.
