Smlthsonlan Astrophysical Observatory & Steward Observatory, The University of Arizona

BIMONTHLY SUMMARY

July - August 2003

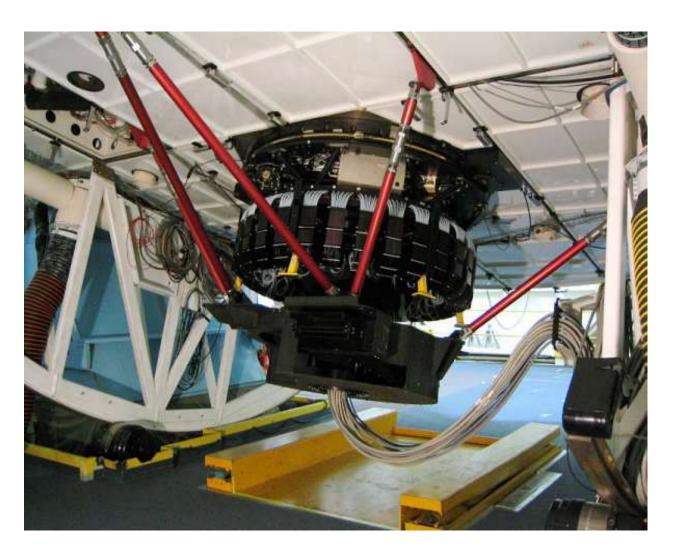
The Hectospec/Hectochelle fiber positioner and derotator mounted at the Cassegrain focus, prior to installing the fibers. (Image by D. Fabricant.)

Another major milestone for the MMT and SAO was marked on July 18 with the delivery to the summit of the 6,000 lb Hectospec fiber positioner. The following day the equipment was rigged for the overhead lift into the observing chamber. This was a very tight fit requiring a coordinated tilt of the telescope while six people pushed the instrument through the narrow gap, all in the face of a thunderstorm that bore down upon the mountain.

Over the next five weeks crews from SAO and MMTO uncrated the instrument and assembled the two halves (derotator and positioner) using the newly installed laboratory instrument lift. After assembly the positioner was test fitted onto the telescope. The test fit went well, but revealed several minor problems in the handling clearances that were solved one by one. After software checkout, Joe Zajac (SAO) arrived to install the 320 fibers into the derotator. He was assisted in this painstaking task by Steve Nichols and a temporary crew assembled by MMTO for the purpose: Creighton Chute, Jim Harper, Geneva Hickey, and Alberto Ramos. Kudos to the team for a job well done.

Following the fiber installation, an optical test grid was inserted into the positioner for calibration purposes. The fiber positioner was then rolled from the garage and mounted onto the telescope while the procedure was carefully documented. Finally, the derotator was tested with the real fibers. Calibration and flexure tests of the full system were run at several elevations and rotator angles. Several minor mechanical modifications were made to the positioner and positioner cart. The
