MMTO Technical Memorandum #03-4

Modifications to the f/9 Secondary Mirror Hardpoints

MMTO Technical Memo #03-4, 18 Feb. 2003

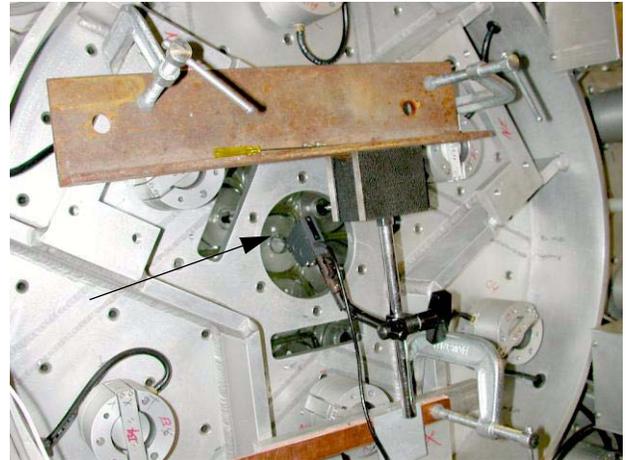
Figure 5: Setup for measuring the decenter of the mirror with respect to cell using a Mitutoyo gauge contacting the inside edge of the central perforation in the mirror backplate.

Although the newly modified hardware would surely increase the robustness of the mirror defining points in the presence of wind buffeting, the modifications did not eliminate the high-elevation collimation discontinuity shown in Figure 1. Additionally, we noticed that the lateral support servo became unstable in the region of the discontinuity. Extensive testing of the electronics failed to show an electronic problem.

After close inspection, we discovered a single-point contact of an axial earthquake pad with the mirror backplate. After eliminating this contact, the lateral support servo was still unstable

in the region of the discontinuity suggesting compliance in the load path from the tangent arm load cells to the mirror.
